FRONT BUMPER INSTALLATION INSTRUCTIONS

03-09 Dodge Ram Truck

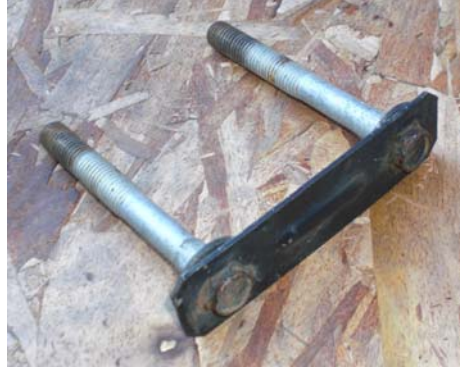
Figure 1: Bumper bolt plate

- Unplug the fog light wire and disconnect the wire from the clip attached to the bumper
- The stock bumper is held in place by two bolt plates (see *Figure 1* below)—remove the nuts from these.

- Have someone hold the bumper while you remove these bolt plates—**CAUTION!**—**Once you pull out the bolt plates, the bumper will be free to fall. Do not lay under the bumper when removing these bolt plates.**

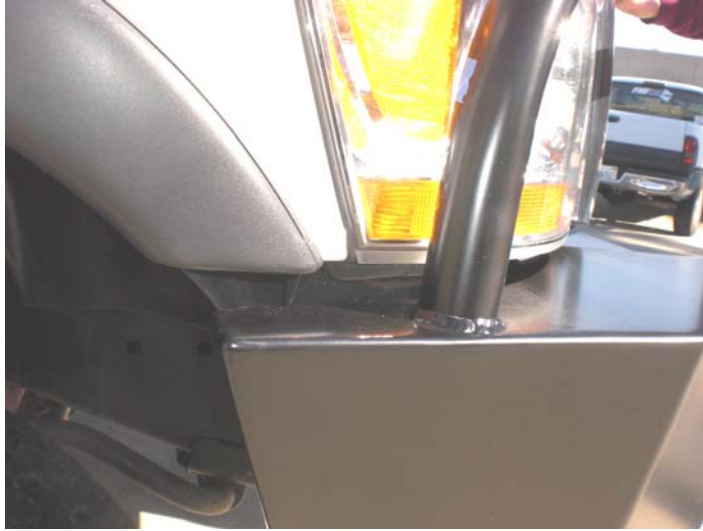
Figure 3: Correct body gap with new bumper installed

- Check the bumper with a bubble level to make sure it is even, then examine the gap between the bumper and body on all sides to make sure it is not too close—it should be around $\frac{3}{4}$ "
